## **RETURN TO CAJON PASS - ABOVE THE SUMMIT**

Charles H Bogart

On our last day at Cajon Pass we spent our morning at two different pull offs located alongside of California 138, just west of Summit. Below are some photos of the trains we saw.

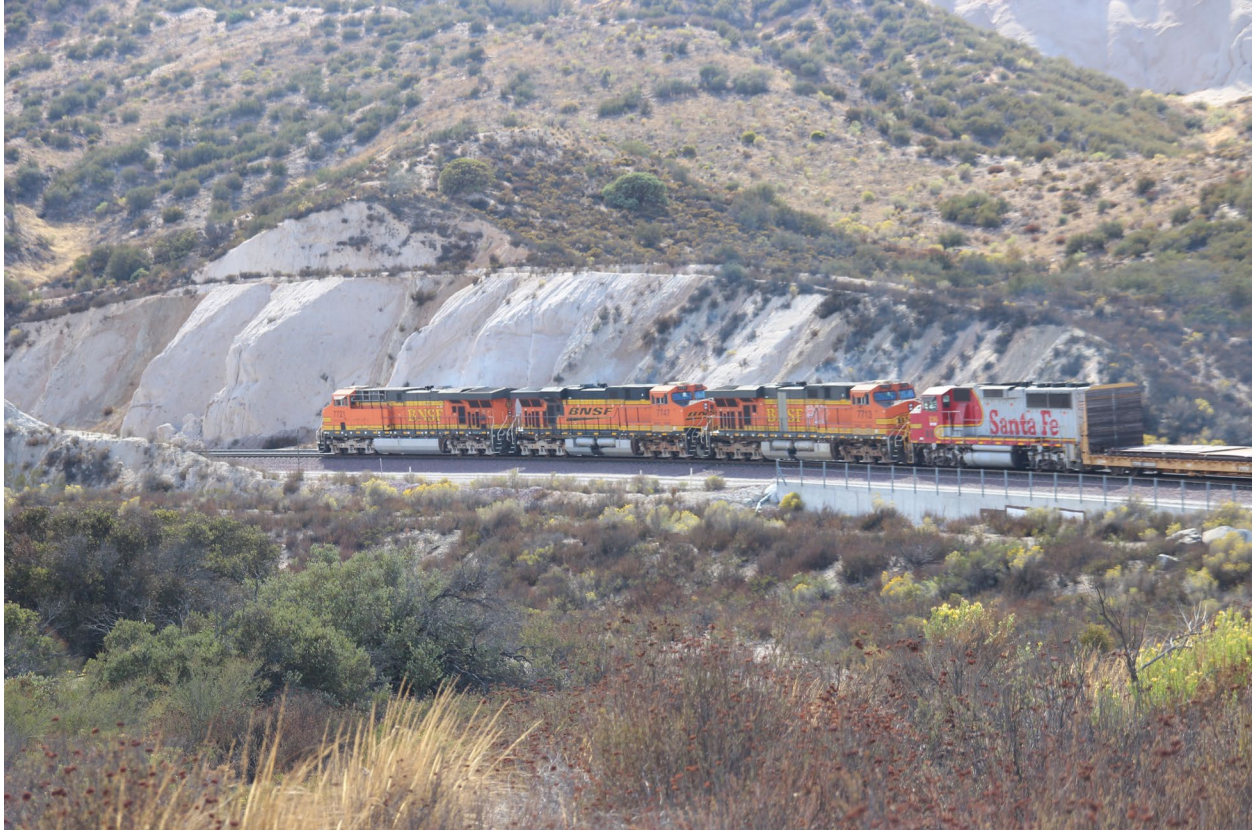
Heading westbound FROM Summit are BN-SF 7721, a GE ES44DC; BN-SF 7747, a GE ES44DC; BN-SF 7713, a GE ES44DC; and BN-SF 136, a GM GP60M; with a manifest train behind them. BN-SF 136 was the only Warbonnet unit we saw during our visit to Cajon.

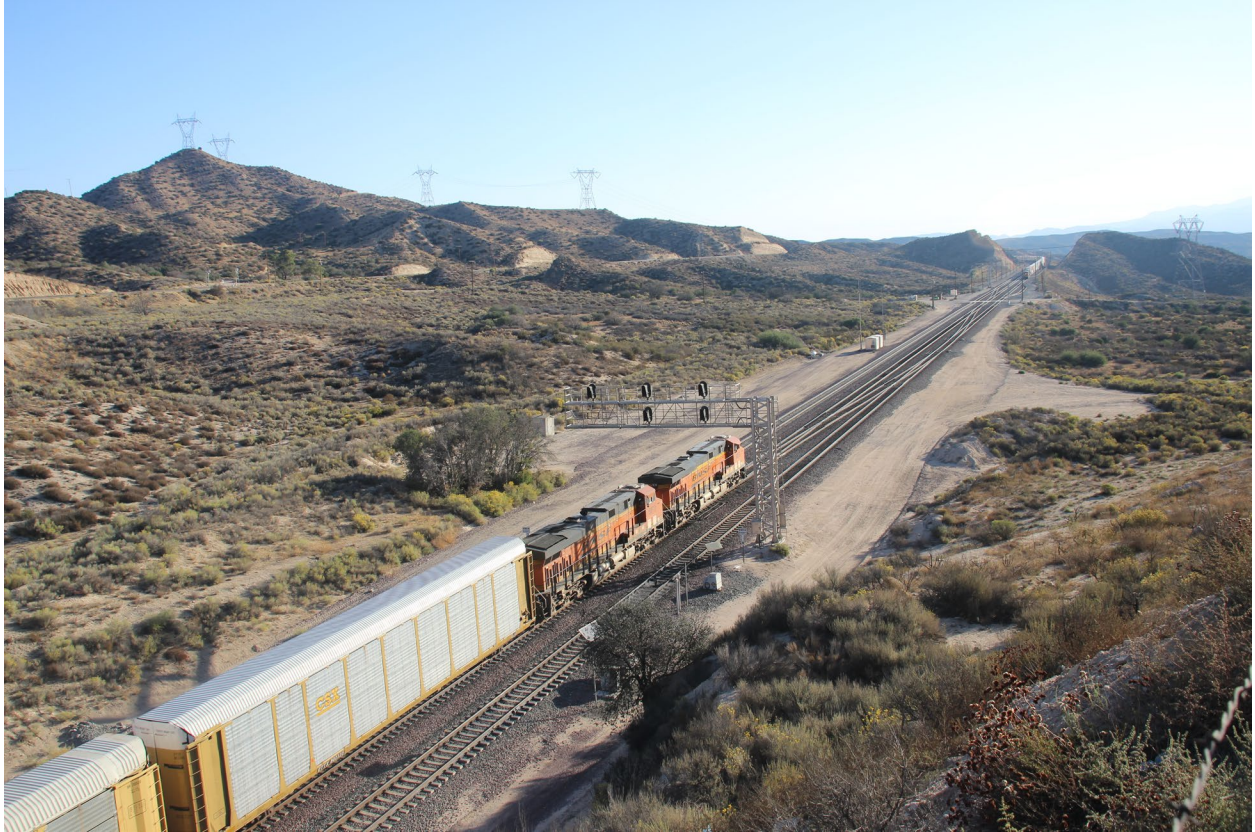
BN-SF 6853 and BN-SF 6873, both GE ES44C4, lead a unit train of autoracks eastward over track #2. The two locomotives as they pass under the signal lights have reached the west crest of Cajon Pass. Just visible in the distance is a westbound train on track #3 headed by BN-SF 7380 and BN-SF 7547. Once BN-SF 6853 clears Summit BN-SF will be routed to Track #2 for the journey to Los Angeles.

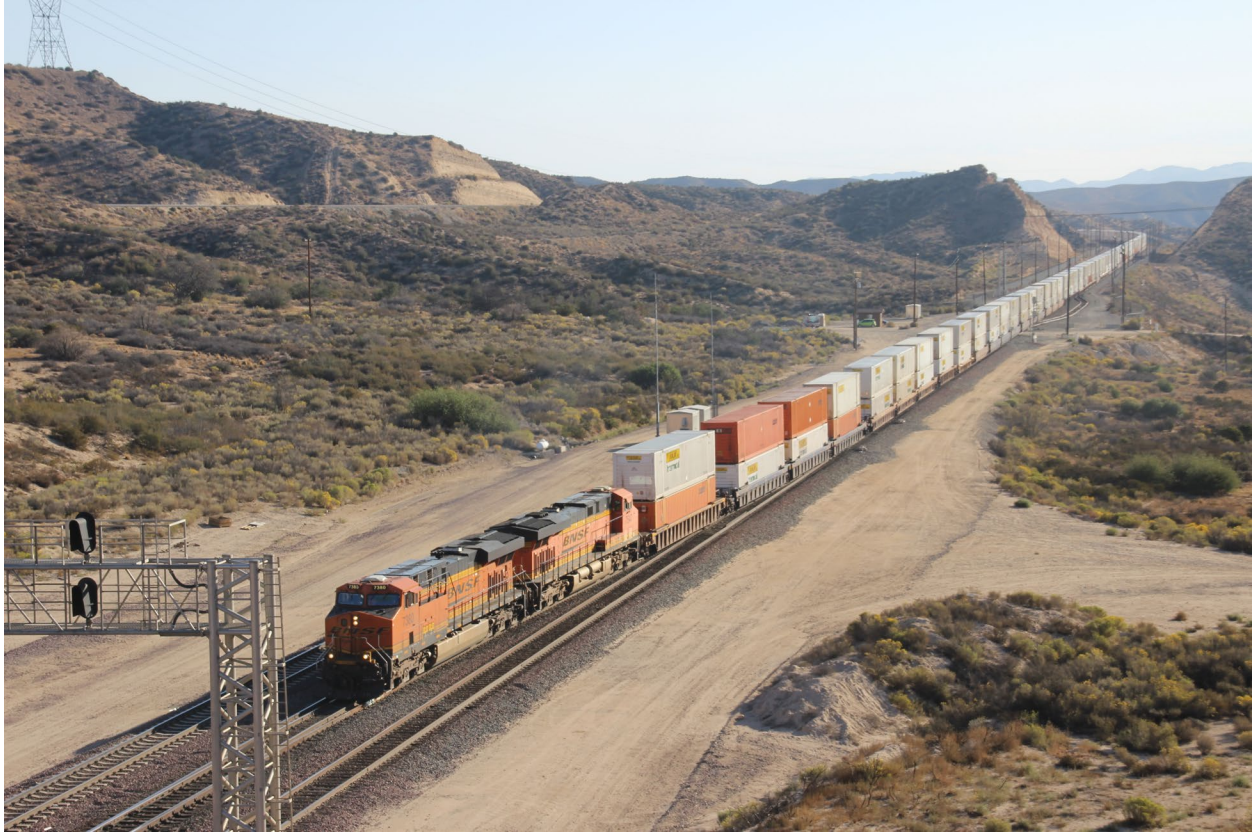
BN-SF 7380 and BN-SF 7547, both GE ES44AC units, having been given the “Highball” are on the move west. They are crossing from Track #3 to Track #2 for the journey down the west side of Cajon Pass.

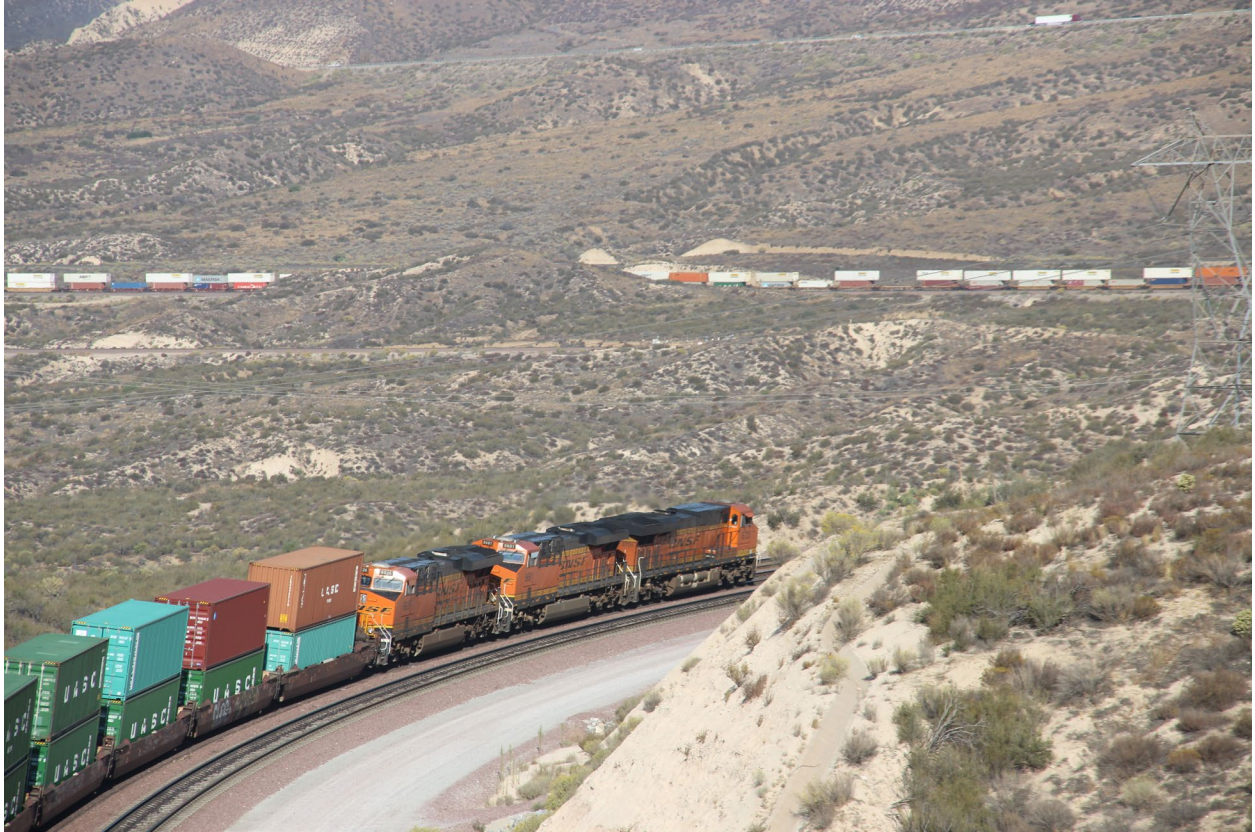
BN-SF 6720, BN-SF 6681, and BN-SF 6926, all GE ES44AC, are seen pulling a unit stack train down the west side of Cajon Pass using Track #2. In the distance another BN-SF train, containing cars loaded with containers and trailers, is fighting its way up the hill to Summit.

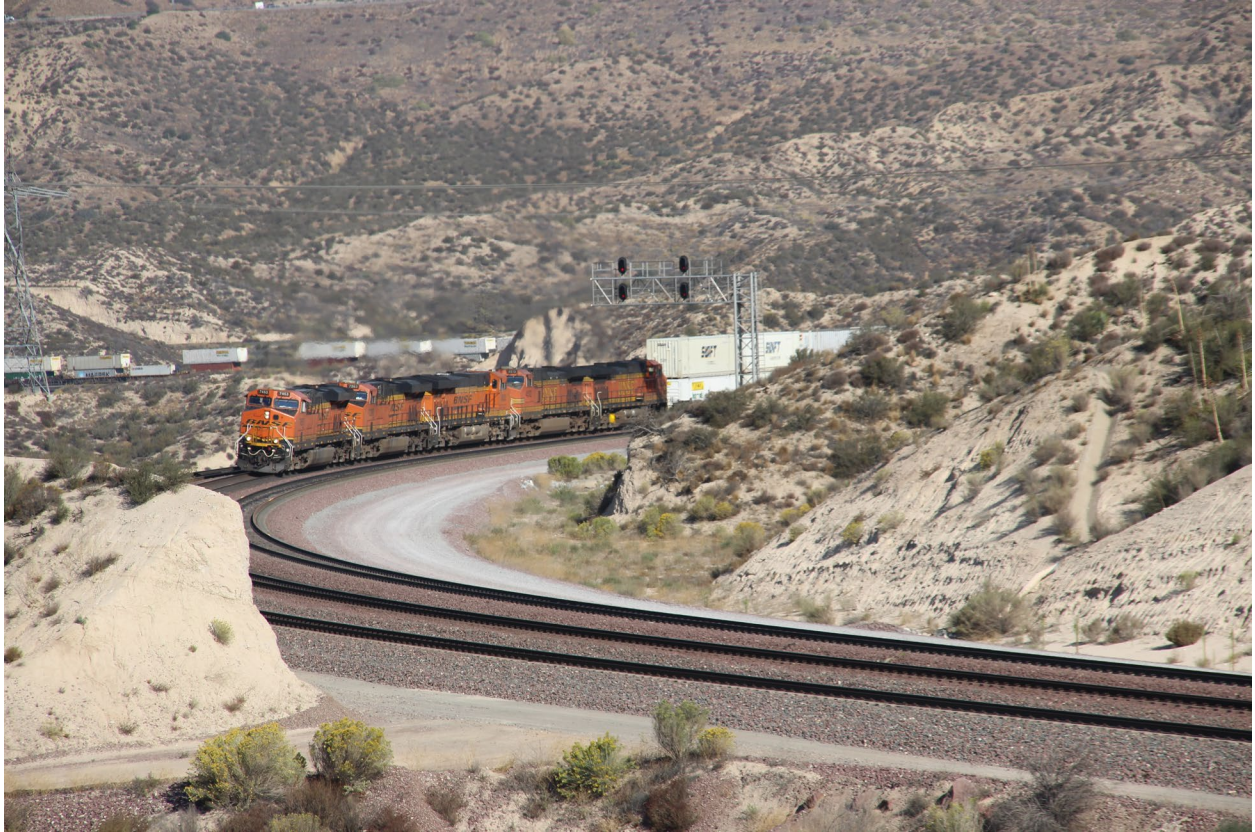
BN-SF 7453, a GE ES44DC; BN-SF 7283, a GE ES44DC; BN-SF 8002, a GE ES44C4; BN-SF 4512, a GE C44-9W; and BN-SF 4395, a GE C44-9W; are at Silverwood Mile Post 56.6. It is .7 miles to Summit, Mile Post 55.9, and their train stretches out behind them into the far distance. There are two helpers at the rear of this train and they will be needed because the train will catch a red signal just short of the top of the grade. With great engineering skill its crew will bring the train from a dead stop on this 3 percent grade and march the train through the Pass.

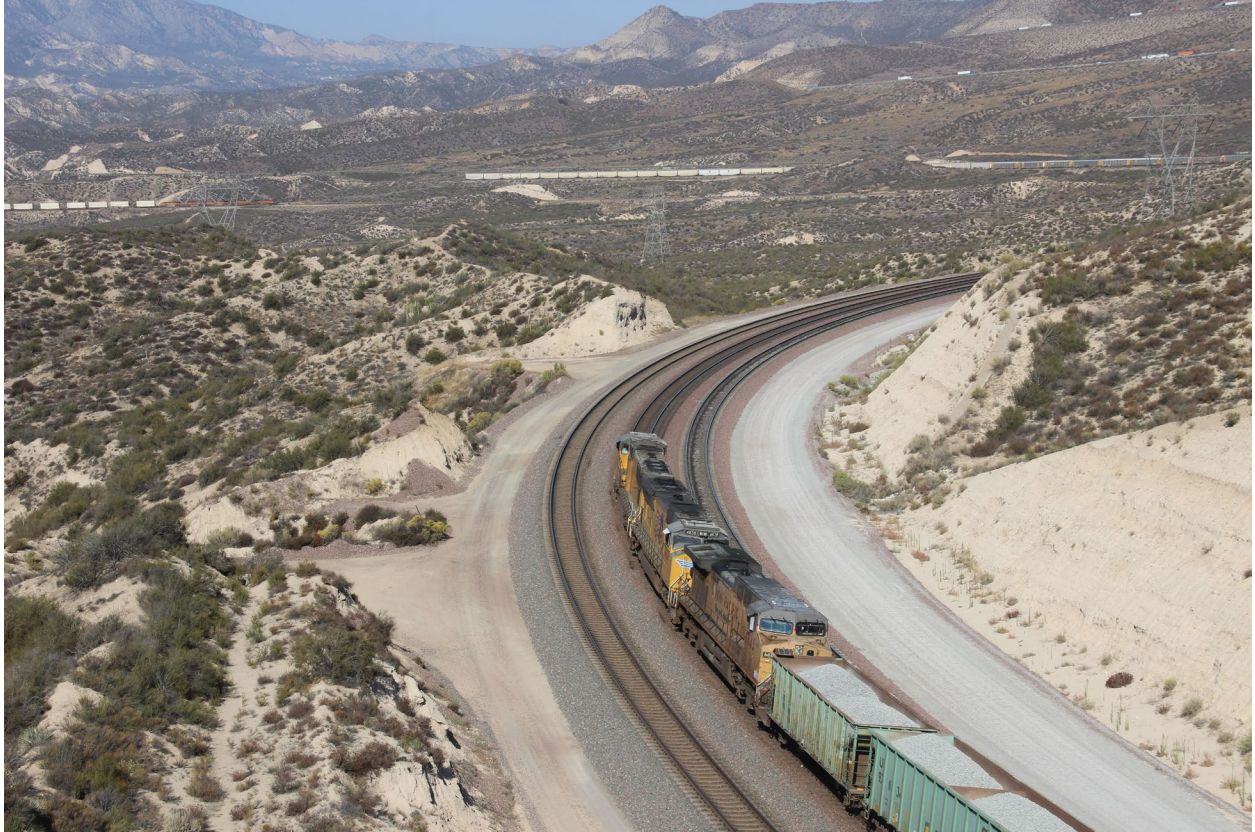
UP 4172, a GM SD70M; UP 4838 a GM SD70M; and UP 6845, a GE C44AC; running on Track #2, are westbound heading a 40 car train of loaded ballast cars. It is all dynamic breaking. In the lower left coming eastbound on Track #1 is a 120 car stack train headed by five BN-SF locomotives, all running in Notch 8. In the upper right, on Track #1, can be seen an eastbound autorack train headed by four BN-SF locomotives.

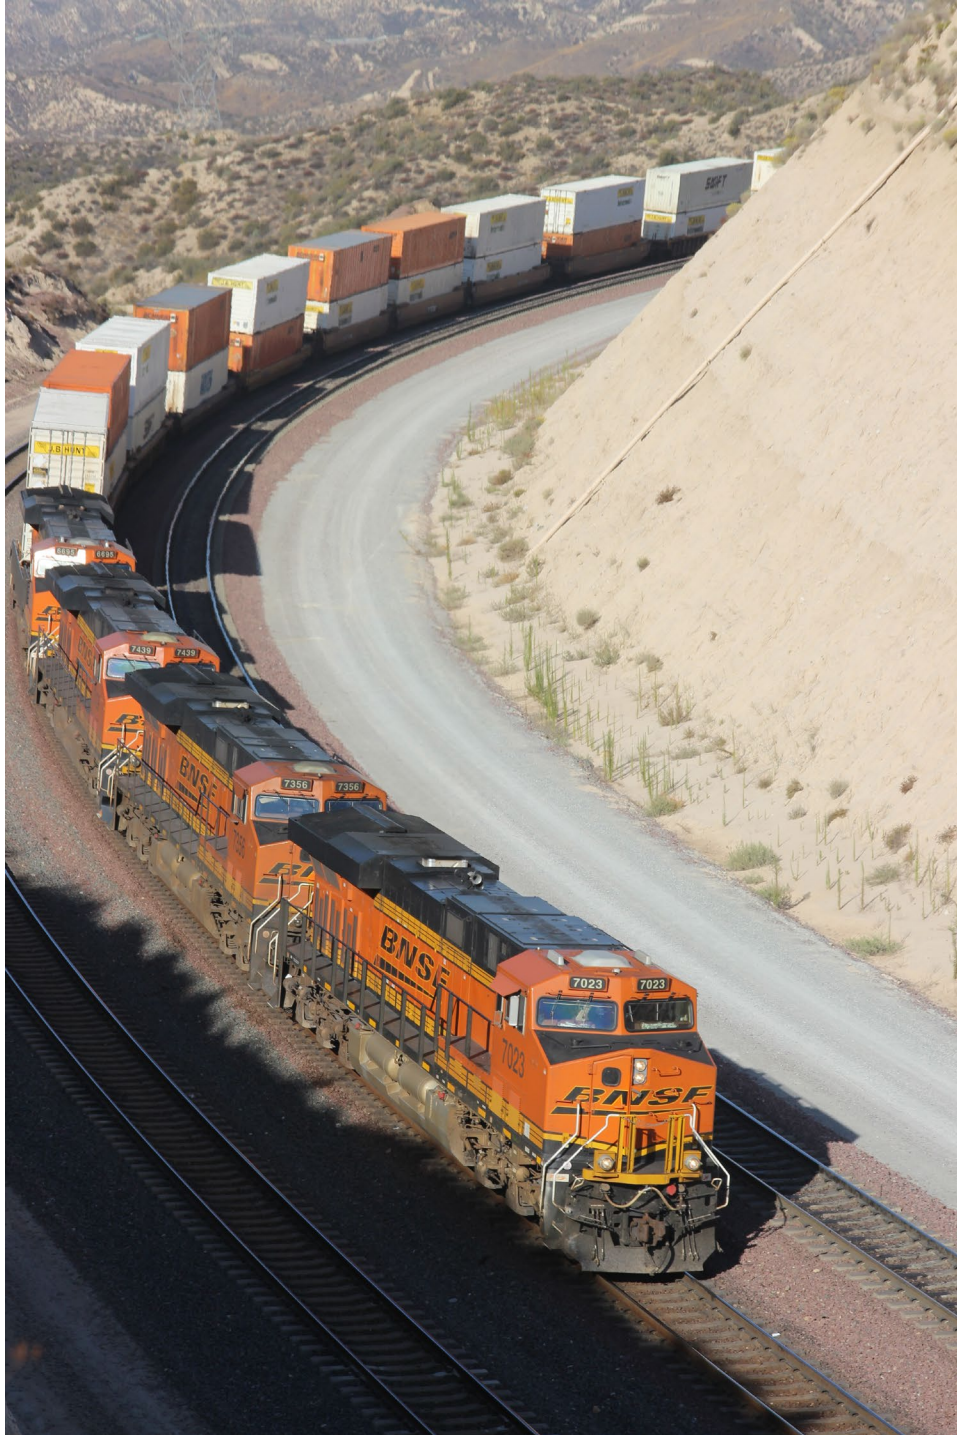
BN-SF 7023, a GE ES44C4; BN-SF 7356, a GE ES44DC, BN-SF 7439, a GE ES44DC; and BN-SF 6695, a GE ES44C4; are four car lengths short of topping the west side of Cajon Pass. They were pulling a 106 car train of double stacks. The only vehicles I saw on the nice gravel road to the right of the train were BN-SF Maintenance-of-Way trucks.

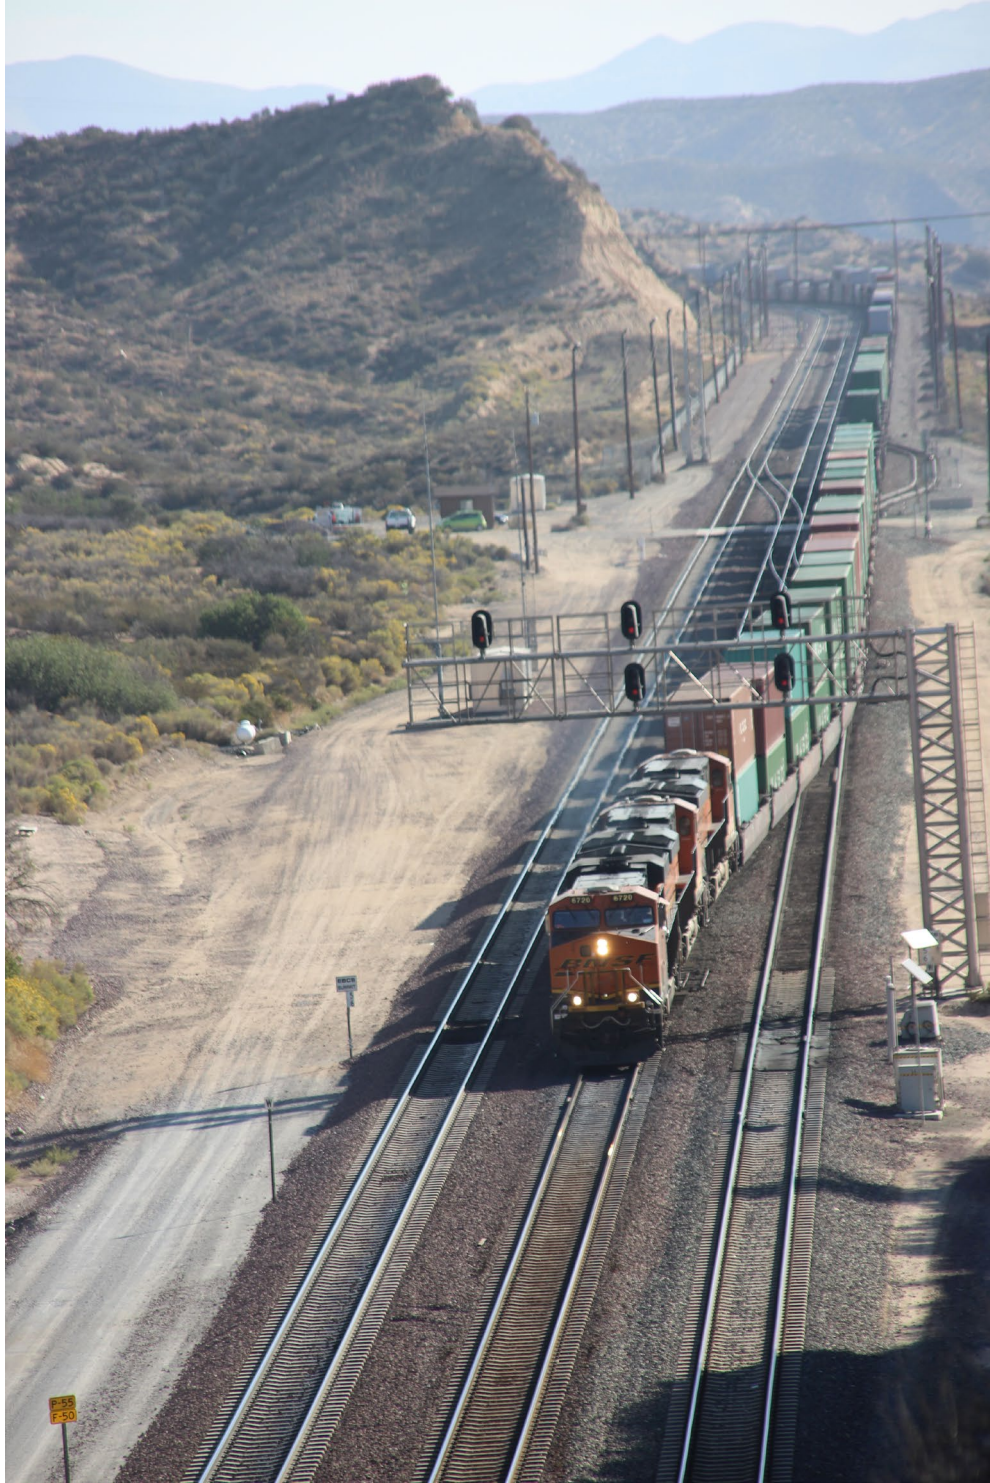
BN-SF 6720, BN-SF 6681, and BN-SF 6926, all GE ES44C4 locomotives, are seen westbound crossing from Track #3 to Track #2. The three signs to the left of Track #1 carry the following messages, “P-55 F-50”; “W”; and “EBCS SUMMIT 56”. The next photo is a close up of the signal boxes seen to the right of the locomotive. Note the road crossing upper center, more on this road later. I was told that the two-car siding above the road was for setting out bad order cars. It looked like it could hold two cars.

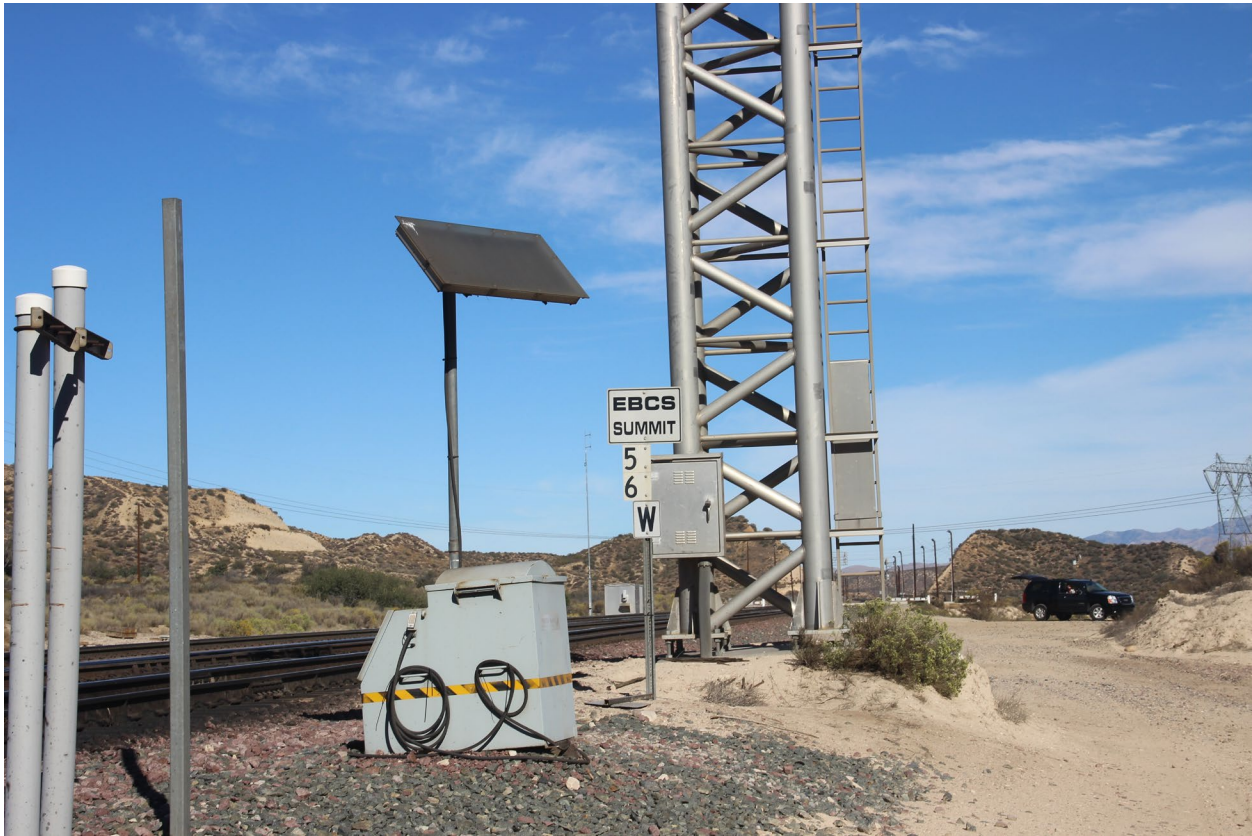
A close up of the BN-SF signage on the south side of the track as one enters the yard at Summit from the west. The Whistle Board is for the road crossing that leads to the BN-SF's Summit Station. This road is blocked at California 138 by a locked gate, with a large sign saying BN-SF Property – No Trespassing.” I chose to believe what the sign said and did not try and take any photos from this area. However, I saw both hikers and motorcycle riders cross the track at this location, but I did note that the motorcycle riders had to dismount and pull their machines under the gate.

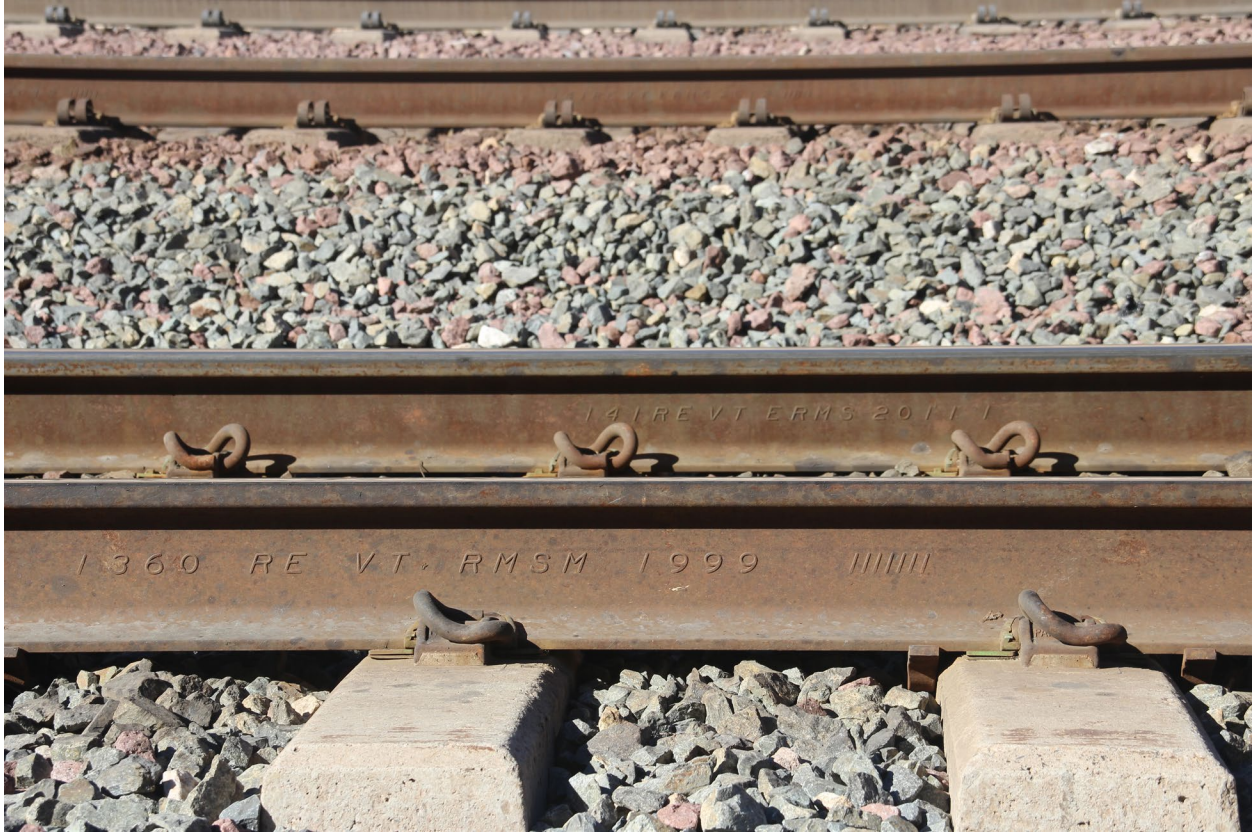
A close up of the rail at Summit. Note that the inner rail which receives much of the lateral weight of the train cars' wheels, as the train go through this bend, is 141-pound rail while the outer rail, which receives less of the train's lateral weight, is 136 pound rail
